Asbestos Refurbishment Survey Report

Chittlehampton Village Hall, Umberleigh, Devon
EX37 9PS

Replacement of existing roof together with refurbishment of WC's and redecoration throughout.

Survey Reference: J000853

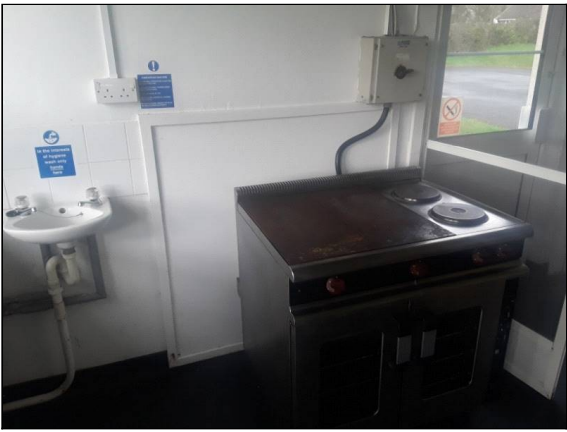
Item No.	Survey Date:	Survey Type	Floor	Analysis
	8	22 Feb 2023	Refurbishment Survey	Ground Floor	Chrysotile (1)
	Building	Room	Item	Quantity	Removal Category
	Chittlehampton Village Hall	Kitchen 1 (G05)	Cement panel to wall behind oven as seen	1m ²	Non-licensed
	Sample No (S,SP,P,As)	Product Type	Surface Treatment	Condition	Accessibility
	MF009800 (S)	Asbestos Cement (1)	Surface Sealed (1)	Good Condition (0)	Usually inaccessible or unlikely to be disturbed
	Material Risk Score	3			
Recommended action	D - No Attention Required, Label				
Surveyor comments	N/A

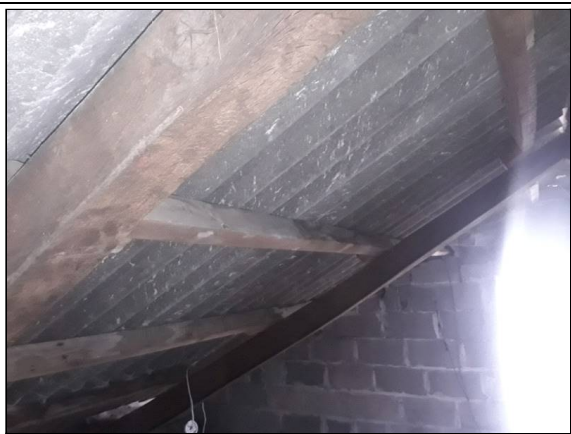
Item No	Building	Floor	Room	Item	Material	Risk assessment Score	Recommendations	Removal Category
26	Chittlehampton Village Hall	Roof Void	Projection Room (R01)	Underside corrugated cement roof sheets	Asbestos Cement	LOW (5)	D - No Attention Required, Label	Non-licensed
33	Chittlehampton Village Hall	External	Externals (E01)	Corrugated cement roof sheets	Asbestos Cement	LOW (5)	D - No Attention Required, Label	Non-licensed
34	Chittlehampton Village Hall	External	Externals (E01)	Cement cappings to gable ends	Asbestos Cement	LOW (5)	D - No Attention Required, Label	Non-licensed
36	Chittlehampton Village Hall	External	Externals (E01)	Cement rainwater guttering at rear	Asbestos Cement	LOW (5)	D - No Attention Required, Label	Non-licensed
37	Chittlehampton Village Hall	External	Externals (E01)	Cement downpipe	Asbestos Cement	LOW (5)	D - No Attention Required, Label	Non-licensed
38	Chittlehampton Village Hall	External	Externals (E01)	Cement pipes used as floor vents	Asbestos Cement	LOW (5)	D - No Attention Required, Label	Non-licensed

Item No.	Survey Date:	Survey Type	Floor	Analysis
	26	22 Feb 2023	Refurbishment Survey	Roof Void	Amo + Chrys + Croc (3)
	Building	Room	Item	Quantity	Removal Category
	Chittlehampton Village Hall	Projection Room (R01)	Underside corrugated cement roof sheets as seen	50m ²	Non-licensed
	Sample No (S,SP,P,As)	Product Type	Surface Treatment	Condition	Accessibility
	MF009802 (S)	Asbestos Cement (1)	Surface Sealed (1)	Good Condition (0)	Usually inaccessible or unlikely to be disturbed
	Material Risk Score	5			
Recommended action	D - No Attention Required, Label				
Surveyor comments	N/A

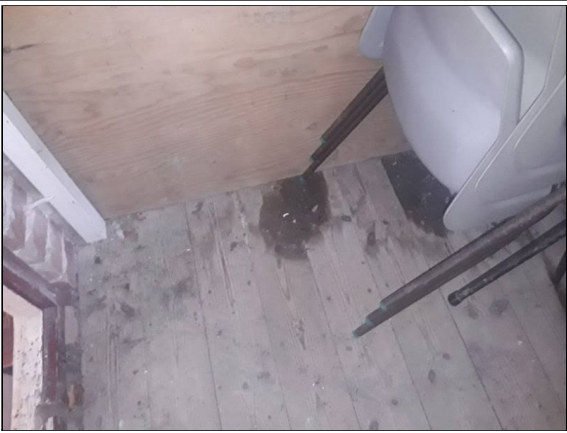
Item No	Building	Floor	Room	Item	Material	Risk assessment Score	Recommendations	Removal Category
27	Chittlehampton Village Hall	Roof Void	Projection Room (R01)	Dust and debris to floor including fibreglass insulation	Dust/Debris	MEDIUM (7)	C - Repair or Remove	Non-licensed

Item No.	Survey Date:	Survey Type	Floor	Analysis
	27	22 Feb 2023	Refurbishment Survey	Roof Void	Chrysotile (1)
	Building	Room	Item	Quantity	Removal Category
	Chittlehampton Village Hall	Projection Room (R01)	Dust and debris to floor including fibreglass insulation as seen	20m ²	Non-licensed
	Sample No (S,SP,P,As)	Product Type	Surface Treatment	Condition	Accessibility
	MF009803 (S)	Dust/Debris (3)	Surface Sealed (1)	Medium Damage (2)	Occasionally likely to be disturbed
	Material Risk Score				
7					
Recommended action	C - Repair or Remove				
Surveyor comments	N/A

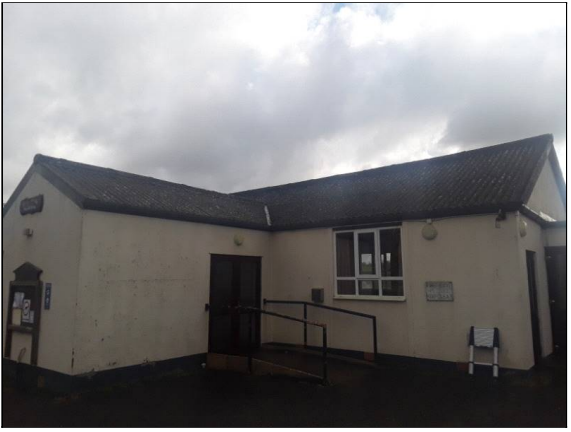
33	Chittlehampton Village Hall	External	Externals (E01), Corrugated cement roof sheets as seen	SP As MF009802	Asbestos Cement	Good Condition	Surface Sealed	Amo + Chrys + Croc	300m ²	Usually inaccessible or unlikely to be disturbed	5	D - No Attention Required, Label	N/A
34	Chittlehampton Village Hall	External	Externals (E01), Cement cappings to gable ends as seen	SP As MF009802	Asbestos Cement	Good Condition	Surface Sealed	Amo + Chrys + Croc	40m	Usually inaccessible or unlikely to be disturbed	5	D - No Attention Required, Label	N/A
36	Chittlehampton Village Hall	External	Externals (E01), Cement rainwater guttering at rear as seen	S MF009806	Asbestos Cement	Good Condition	Surface Sealed	Amo + Chrys + Croc	15m	Usually inaccessible or unlikely to be disturbed	5	D - No Attention Required, Label	N/A
37	Chittlehampton Village Hall	External	Externals (E01), Cement downpipe as seen	SP As MF009806	Asbestos Cement	Good Condition	Surface Sealed	Amo + Chrys + Croc	3m	Usually inaccessible or unlikely to be disturbed	5	D - No Attention Required, Label	N/A

Item No.	Survey Date:	Survey Type	Floor	Analysis
	33	22 Feb 2023	Refurbishment Survey	External	Amo + Chrys + Croc (3)
	Building	Room	Item	Quantity	Removal Category
	Chittlehampton Village Hall	Externals (E01)	Corrugated cement roof sheets as seen	300m ²	Non-licensed
	Sample No (S,SP,P,As)	Product Type	Surface Treatment	Condition	Accessibility
	As MF009802 (SP)	Asbestos Cement (1)	Surface Sealed (1)	Good Condition (0)	Usually inaccessible or unlikely to be disturbed
	Material Risk Score	5			
Recommended action	D - No Attention Required, Label				
Surveyor comments	N/A

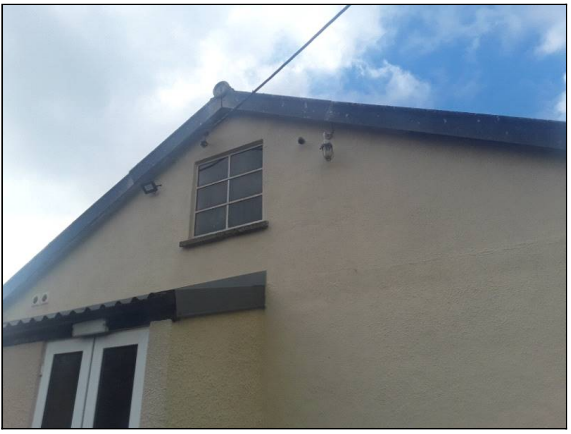
Item No.	Survey Date:	Survey Type	Floor	Analysis
	34	22 Feb 2023	Refurbishment Survey	External	Amo + Chrys + Croc (3)
	Building	Room	Item	Quantity	Removal Category
	Chittlehampton Village Hall	Externals (E01)	Cement cappings to gable ends as seen	40m	Non-licensed
	Sample No (S,SP,P,As)	Product Type	Surface Treatment	Condition	Accessibility
	As MF009802 (SP)	Asbestos Cement (1)	Surface Sealed (1)	Good Condition (0)	Usually inaccessible or unlikely to be disturbed
	Material Risk Score	5			
Recommended action	D - No Attention Required, Label				
Surveyor comments	N/A

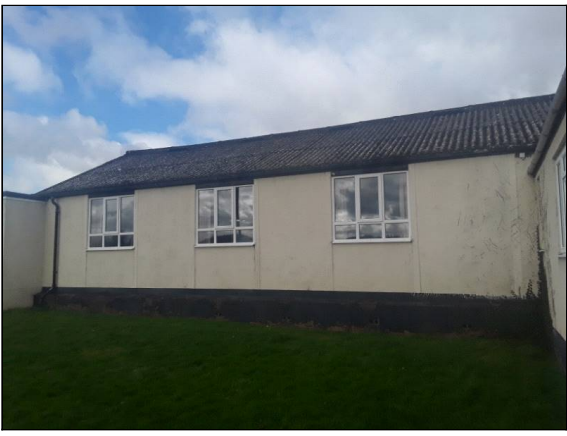
Item No.	Survey Date:	Survey Type	Floor	Analysis
	36	22 Feb 2023	Refurbishment Survey	External	Amo + Chrys + Croc (3)
	Building	Room	Item	Quantity	Removal Category
	Chittlehampton Village Hall	Externals (E01)	Cement rainwater guttering at rear as seen	15m	Non-licensed
	Sample No (S,SP,P,As)	Product Type	Surface Treatment	Condition	Accessibility
	MF009806 (S)	Asbestos Cement (1)	Surface Sealed (1)	Good Condition (0)	Usually inaccessible or unlikely to be disturbed
	Material Risk Score	5			
Recommended action	D - No Attention Required, Label				
Surveyor comments	N/A

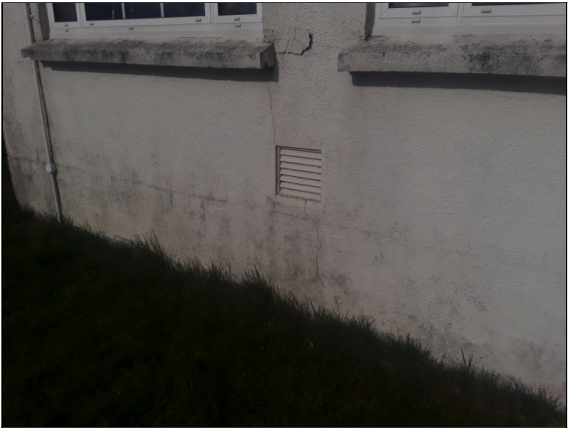
Item No.	Survey Date:	Survey Type	Floor	Analysis
	39	22 Feb 2023	Refurbishment Survey	External	N/A
	Building	Room	Item	Quantity	Removal Category
	Chittlehampton Village Hall	Externals (E01)	No access within wall vents Presume asbestos components within	N/A	-
	Sample No (S,SP,P,As)	Product Type	Surface Treatment	Condition	Accessibility
	Visual (P)	N/A	N/A	N/A	N/A
	Material Risk Score	N/A			
Recommended action	Inspection Required				
Surveyor comments	N/A
