Fire Risk Assessment

Name: Chittlehampton Village Hall

Date of risk assessment: September 2023

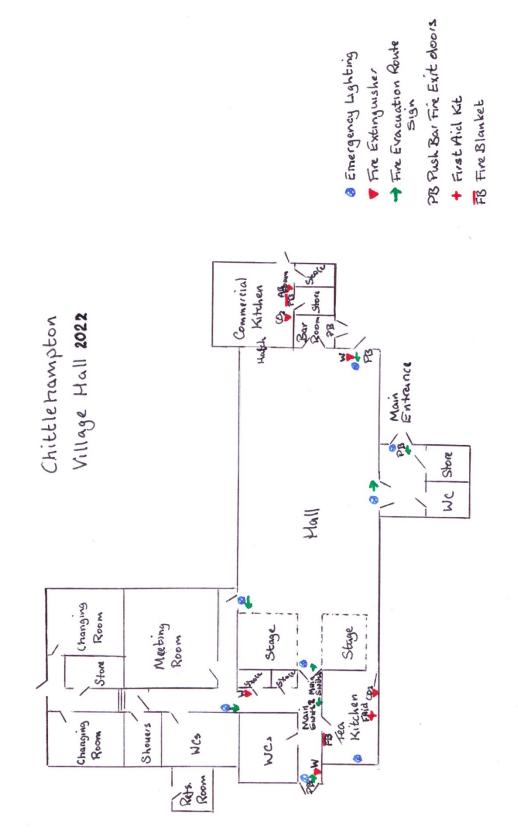
Plan of premises drawing

There is no fire detection systems in the premises. The alarms are manual. There are no smoke sensors and no noxious gas sensors in the premises.
