Asbestos Refurbishment Survey Report

Chittlehampton Village Hall, Umberleigh, Devon
EX37 9PS

Replacement of existing roof together with refurbishment of WC's and redecoration throughout.

Survey Reference: J000853

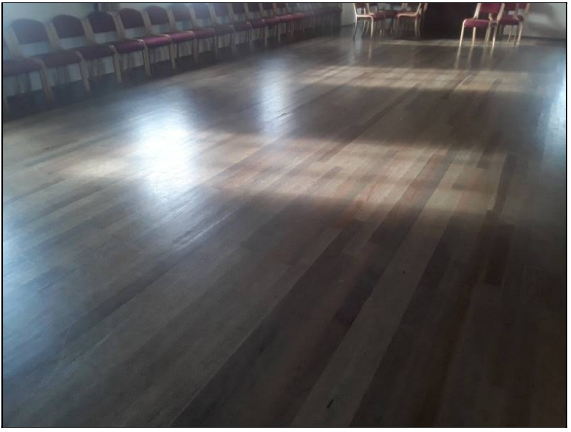
Item No.	Survey Date:	Survey Type	Floor	Analysis
	5	22 Feb 2023	Refurbishment Survey	Ground Floor	N/A
	Building	Room	Item	Quantity	Removal Category
	Chittlehampton Village Hall	Main Hall (G04)	Timber flooring No suspect materials found	N/A	-
	Sample No (S,SP,P,As)	Product Type	Surface Treatment	Condition	Accessibility
	Visual (P)	N/A	N/A	N/A	N/A
	Material Risk Score	N/A			
Recommended action	No further action required				
Surveyor comments	N/A

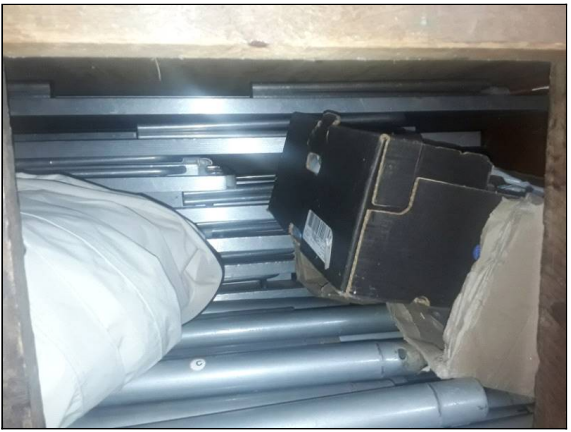
Item No.	Survey Date:	Survey Type	Floor	Analysis
	6	22 Feb 2023	Refurbishment Survey	Ground Floor	N/A
	Building	Room	Item	Quantity	Removal Category
	Chittlehampton Village Hall	Main Hall (G04)	Timber stage inspected No suspect materials	N/A	-
	Sample No (S,SP,P,As)	Product Type	Surface Treatment	Condition	Accessibility
	Visual (P)	N/A	N/A	N/A	N/A
	Material Risk Score	N/A			
Recommended action	No further action required				
Surveyor comments	N/A

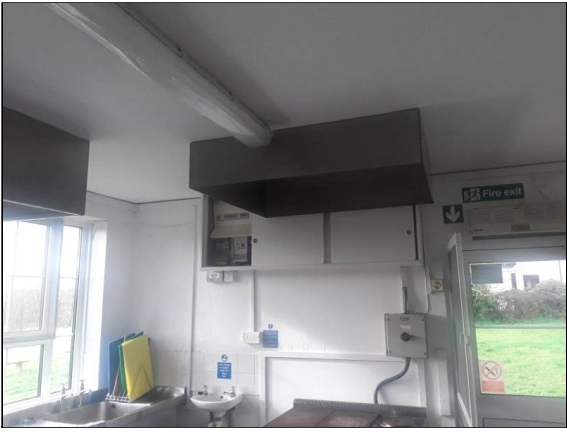
Item No.	Survey Date:	Survey Type	Floor	Analysis
	7	22 Feb 2023	Refurbishment Survey	Ground Floor	N/A
	Building	Room	Item	Quantity	Removal Category
	Chittlehampton Village Hall	Kitchen 1 (G05)	Plasterboard ceiling lining No suspect materials found	N/A	-
	Sample No (S,SP,P,As)	Product Type	Surface Treatment	Condition	Accessibility
	Visual (P)	N/A	N/A	N/A	N/A
	Material Risk Score	N/A			
Recommended action	No further action required				
Surveyor comments	N/A

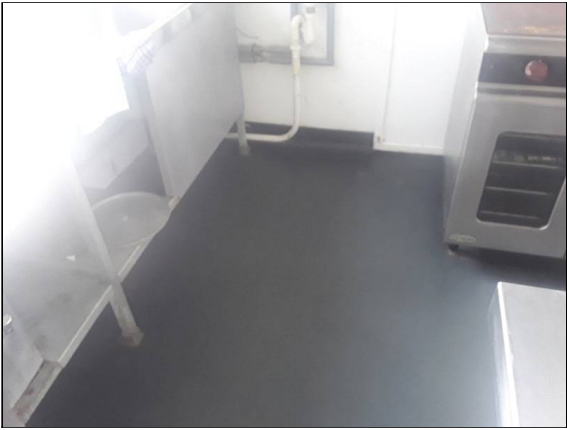
Item No.	Survey Date:	Survey Type	Floor	Analysis
	11	22 Feb 2023	Refurbishment Survey	Ground Floor	N/A
	Building	Room	Item	Quantity	Removal Category
	Chittlehampton Village Hall	Kitchen 1 (G05)	Non slip flooring inspected No suspect materials found	N/A	-
	Sample No (S,SP,P,As)	Product Type	Surface Treatment	Condition	Accessibility
	Visual (P)	N/A	N/A	N/A	N/A
	Material Risk Score				
N/A					
Recommended action	No further action required				
Surveyor comments	N/A

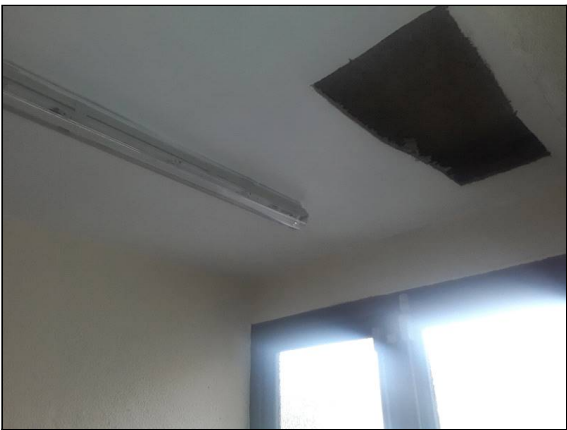
Item No.	Survey Date:	Survey Type	Floor	Analysis
	12	22 Feb 2023	Refurbishment Survey	Ground Floor	N/A
	Building	Room	Item	Quantity	Removal Category
	Chittlehampton Village Hall	Side Entrance (G08)	Plasterboard ceiling lining No suspect materials found	N/A	-
	Sample No (S,SP,P,As)	Product Type	Surface Treatment	Condition	Accessibility
	Visual (P)	N/A	N/A	N/A	N/A
	Material Risk Score				
N/A					
Recommended action	No further action required				
Surveyor comments	N/A

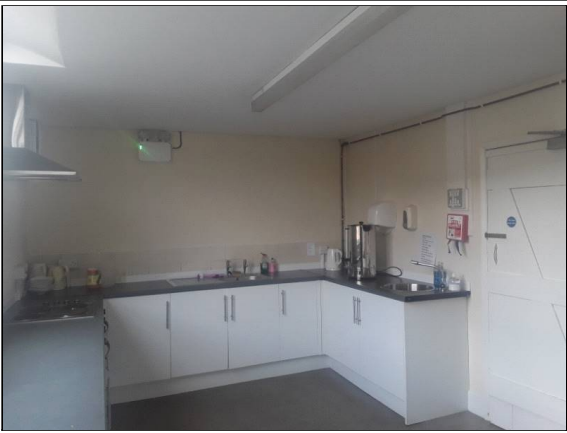
Item No.	Survey Date:	Survey Type	Floor	Analysis
	13	22 Feb 2023	Refurbishment Survey	Ground Floor	N/A
	Building	Room	Item	Quantity	Removal Category
	Chittlehampton Village Hall	Main Kitchen (G09)	Plasterboard ceiling, modern Kitchen Units No suspect materials found	N/A	-
	Sample No (S,SP,P,As)	Product Type	Surface Treatment	Condition	Accessibility
	Visual (P)	N/A	N/A	N/A	N/A
	Material Risk Score	N/A			
Recommended action	No further action required				
Surveyor comments	N/A

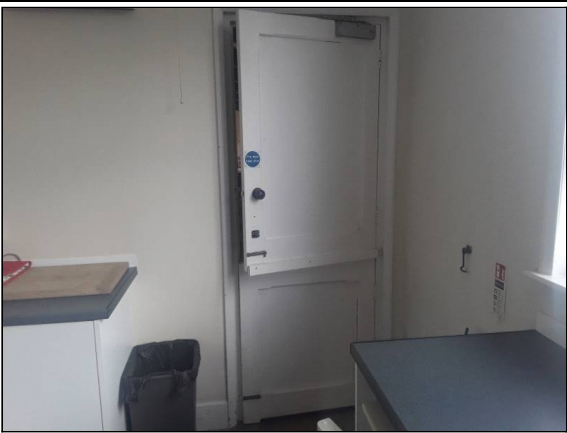
Item No.	Survey Date:	Survey Type	Floor	Analysis
	14	22 Feb 2023	Refurbishment Survey	Ground Floor	No Asbestos Detected
	Building	Room	Item	Quantity	Removal Category
	Chittlehampton Village Hall	Main Kitchen (G09)	Insulating board panels to 2no doors as seen	N/A	-
	Sample No (S,SP,P,As)	Product Type	Surface Treatment	Condition	Accessibility
	MF009801 (S)	N/A	N/A	N/A	N/A
	Material Risk Score	N/A			
Recommended action	No further action required				
Surveyor comments	N/A

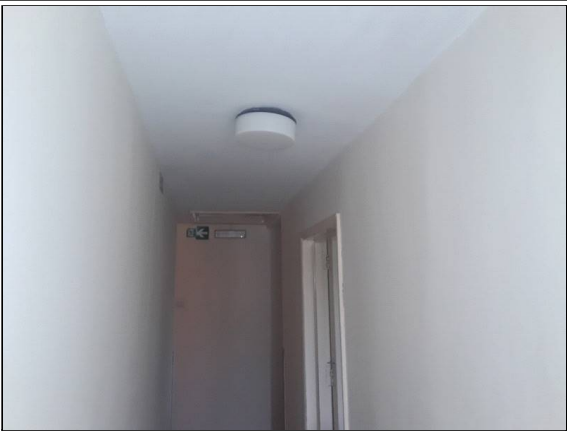
Item No.	Survey Date:	Survey Type	Floor	Analysis
	15	22 Feb 2023	Refurbishment Survey	Ground Floor	N/A
	Building	Room	Item	Quantity	Removal Category
	Chittlehampton Village Hall	WC Lobby (G10)	Plasterboard ceiling lining No suspect materials found	N/A	-
	Sample No (S,SP,P,As)	Product Type	Surface Treatment	Condition	Accessibility
	Visual (P)	N/A	N/A	N/A	N/A
	Material Risk Score	N/A			
Recommended action	No further action required				
Surveyor comments	N/A

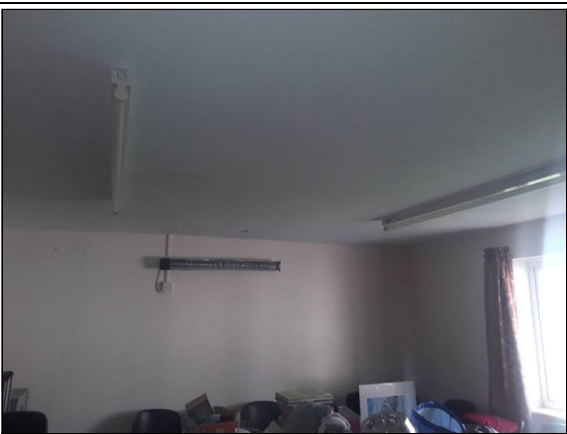
Item No.	Survey Date:	Survey Type	Floor	Analysis
	16	22 Feb 2023	Refurbishment Survey	Ground Floor	N/A
	Building	Room	Item	Quantity	Removal Category
	Chittlehampton Village Hall	Meeting room (G11)	Plasterboard ceiling lining No suspect materials	N/A	-
	Sample No (S,SP,P,As)	Product Type	Surface Treatment	Condition	Accessibility
	Visual (P)	N/A	N/A	N/A	N/A
	Material Risk Score	N/A			
Recommended action	No further action required				
Surveyor comments	N/A

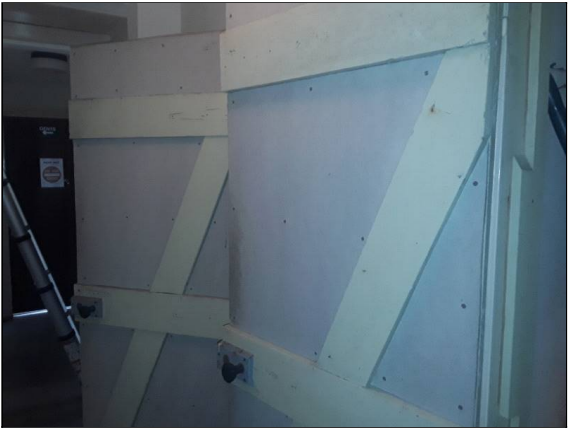
Item No.	Survey Date:	Survey Type	Floor	Analysis
	17	22 Feb 2023	Refurbishment Survey	Ground Floor	No Asbestos Detected
	Building	Room	Item	Quantity	Removal Category
	Chittlehampton Village Hall	WC Lobby (G10)	Insulating board panels to 2no doors as seen	N/A	-
	Sample No (S,SP,P,As)	Product Type	Surface Treatment	Condition	Accessibility
	As MF009801 (SP)	N/A	N/A	N/A	N/A
	Material Risk Score	N/A			
Recommended action	No further action required				
Surveyor comments	N/A

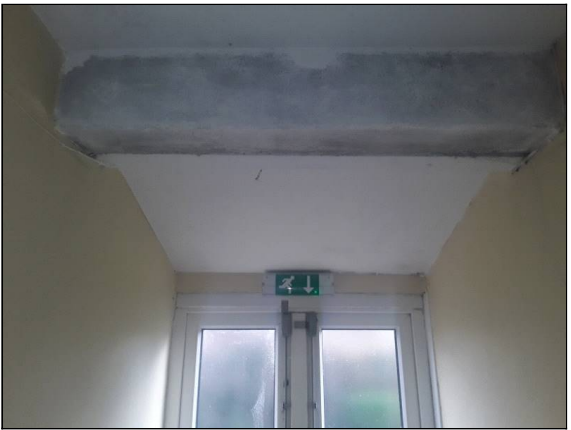
Item No.	Survey Date:	Survey Type	Floor	Analysis
	18	22 Feb 2023	Refurbishment Survey	Ground Floor	N/A
	Building	Room	Item	Quantity	Removal Category
	Chittlehampton Village Hall	WC Lobby (G10)	Plasterboard ceiling to fire escape No suspect materials found	N/A	-
	Sample No (S,SP,P,As)	Product Type	Surface Treatment	Condition	Accessibility
	Visual (P)	N/A	N/A	N/A	N/A
	Material Risk Score	N/A			
Recommended action	No further action required				
Surveyor comments	N/A

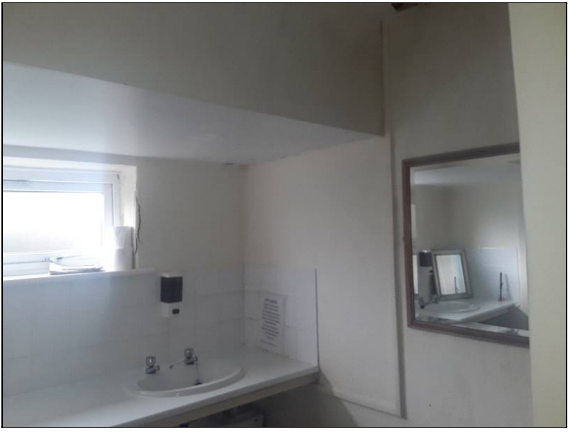
Item No.	Survey Date:	Survey Type	Floor	Analysis
	19	22 Feb 2023	Refurbishment Survey	Ground Floor	N/A
	Building	Room	Item	Quantity	Removal Category
	Chittlehampton Village Hall	Ladies WC (G12)	Plasterboard ceiling lining No suspect materials found	N/A	-
	Sample No (S,SP,P,As)	Product Type	Surface Treatment	Condition	Accessibility
	Visual (P)	N/A	N/A	N/A	N/A
	Material Risk Score				
N/A					
Recommended action	No further action required				
Surveyor comments	N/A

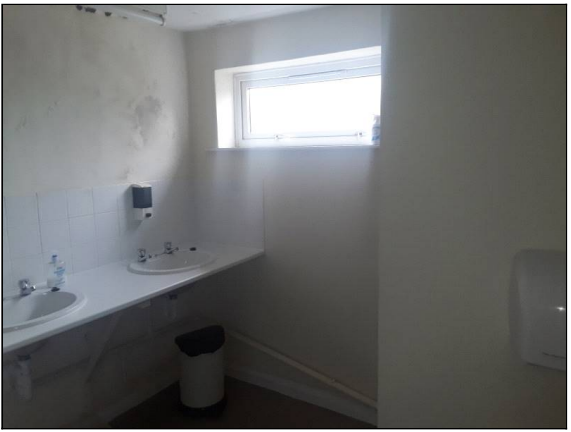
Item No.	Survey Date:	Survey Type	Floor	Analysis
	20	22 Feb 2023	Refurbishment Survey	Ground Floor	N/A
	Building	Room	Item	Quantity	Removal Category
	Chittlehampton Village Hall	Gents WC (G13)	Plasterboard ceiling lining No suspect materials found	N/A	-
	Sample No (S,SP,P,As)	Product Type	Surface Treatment	Condition	Accessibility
	Visual (P)	N/A	N/A	N/A	N/A
	Material Risk Score				
N/A					
Recommended action	No further action required				
Surveyor comments	N/A

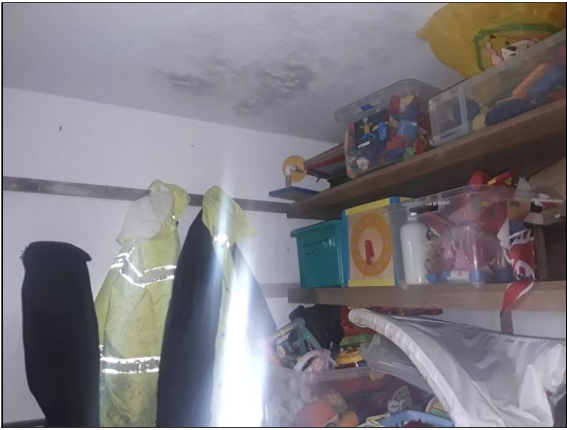
Item No.	Survey Date:	Survey Type	Floor	Analysis
	23	22 Feb 2023	Refurbishment Survey	Ground Floor	N/A
	Building	Room	Item	Quantity	Removal Category
	Chittlehampton Village Hall	Store (G16)	Plasterboard ceiling lining No suspect materials found	N/A	-
	Sample No (S,SP,P,As)	Product Type	Surface Treatment	Condition	Accessibility
	Visual (P)	N/A	N/A	N/A	N/A
	Material Risk Score	N/A			
Recommended action	No further action required				
Surveyor comments	N/A

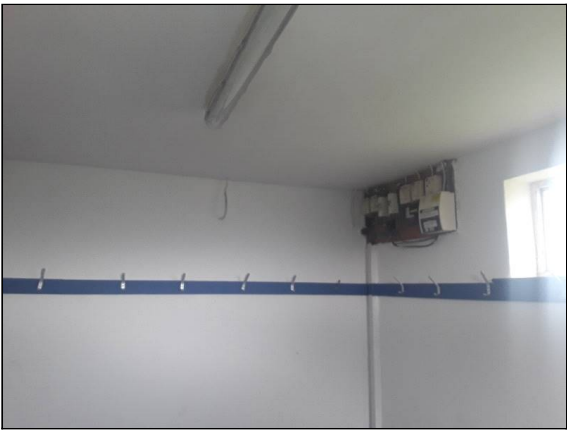
Item No.	Survey Date:	Survey Type	Floor	Analysis
	24	22 Feb 2023	Refurbishment Survey	Ground Floor	N/A
	Building	Room	Item	Quantity	Removal Category
	Chittlehampton Village Hall	Home Changing room (G17)	Plasterboard ceiling lining No suspect materials found	N/A	-
	Sample No (S,SP,P,As)	Product Type	Surface Treatment	Condition	Accessibility
	Visual (P)	N/A	N/A	N/A	N/A
	Material Risk Score	N/A			
Recommended action	No further action required				
Surveyor comments	N/A

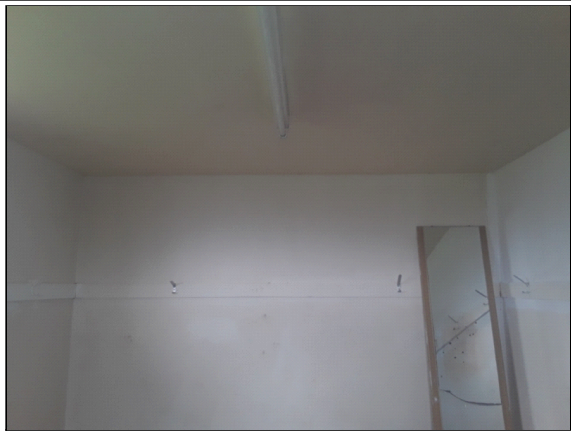
Item No.	Survey Date:	Survey Type	Floor	Analysis
	25	22 Feb 2023	Refurbishment Survey	Ground Floor	N/A
	Building	Room	Item	Quantity	Removal Category
	Chittlehampton Village Hall	Away Changing room (G18)	Plasterboard ceiling lining No suspect materials found	N/A	-
	Sample No (S,SP,P,As)	Product Type	Surface Treatment	Condition	Accessibility
	Visual (P)	N/A	N/A	N/A	N/A
	Material Risk Score	N/A			
Recommended action	No further action required				
Surveyor comments	N/A

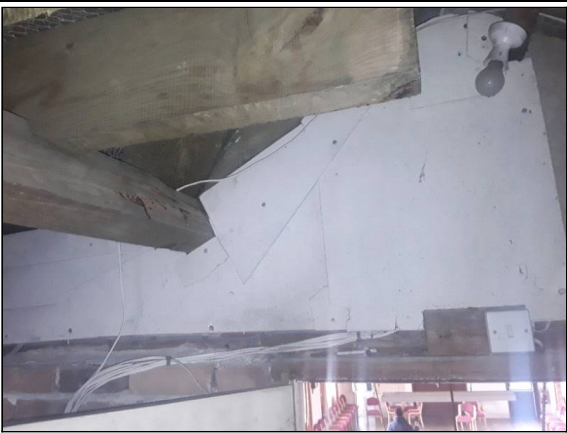
Item No.	Survey Date:	Survey Type	Floor	Analysis
	28	22 Feb 2023	Refurbishment Survey	Roof Void	No Asbestos Detected
	Building	Room	Item	Quantity	Removal Category
	Chittlehampton Village Hall	Projection Room (R01)	Insulating board firebreak panels to main hall as seen	N/A	-
	Sample No (S,SP,P,As)	Product Type	Surface Treatment	Condition	Accessibility
	MF009804 (S)	N/A	N/A	N/A	N/A
	Material Risk Score				
N/A					
Recommended action	No further action required				
Surveyor comments	N/A

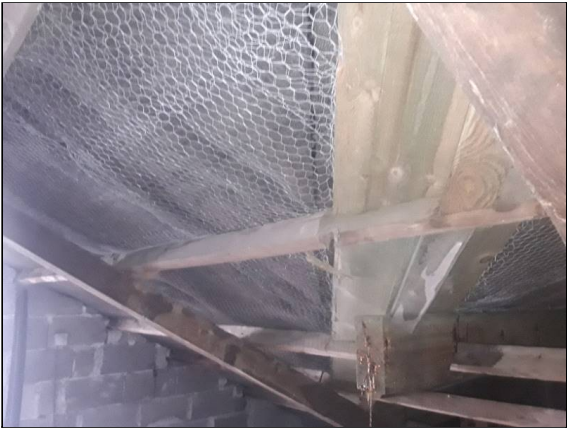
Item No.	Survey Date:	Survey Type	Floor	Analysis
	29	22 Feb 2023	Refurbishment Survey	Roof Void	No Asbestos Detected
	Building	Room	Item	Quantity	Removal Category
	Chittlehampton Village Hall	Projection Room (R01)	Bitumen underfelt to roof as seen	N/A	-
	Sample No (S,SP,P,As)	Product Type	Surface Treatment	Condition	Accessibility
	MF009805 (S)	N/A	N/A	N/A	N/A
	Material Risk Score	N/A			
Recommended action	No further action required				
Surveyor comments	N/A

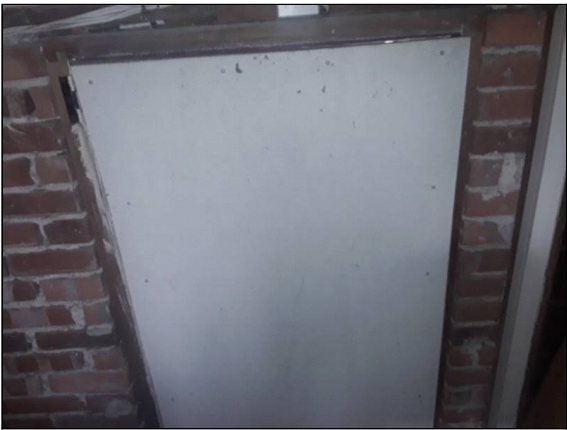
Item No.	Survey Date:	Survey Type	Floor	Analysis
	30	22 Feb 2023	Refurbishment Survey	Roof Void	No Asbestos Detected
	Building	Room	Item	Quantity	Removal Category
	Chittlehampton Village Hall	Projection Room (R01)	Insulating board panel to door as seen	N/A	-
	Sample No (S,SP,P,As)	Product Type	Surface Treatment	Condition	Accessibility
	As MF009804 (SP)	N/A	N/A	N/A	N/A
	Material Risk Score	N/A			
Recommended action	No further action required				
Surveyor comments	N/A

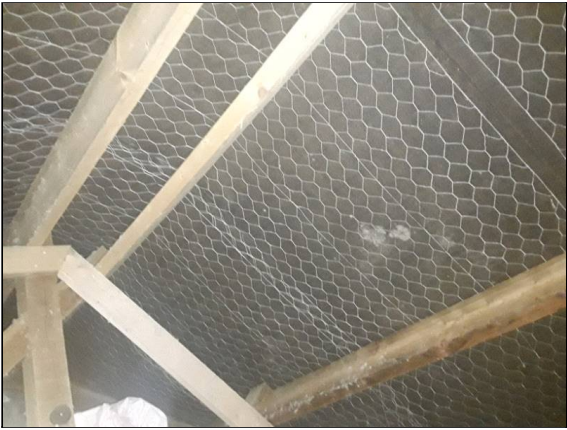
Item No.	Survey Date:	Survey Type	Floor	Analysis
	31	22 Feb 2023	Refurbishment Survey	Roof Void	No Asbestos Detected
	Building	Room	Item	Quantity	Removal Category
	Chittlehampton Village Hall	Entrance Lobby (R02)	Bitumen underfelt as seen	N/A	-
	Sample No (S,SP,P,As)	Product Type	Surface Treatment	Condition	Accessibility
	As MF009805 (SP)	N/A	N/A	N/A	N/A
	Material Risk Score	N/A			
	Recommended action	No further action required			
Surveyor comments	N/A

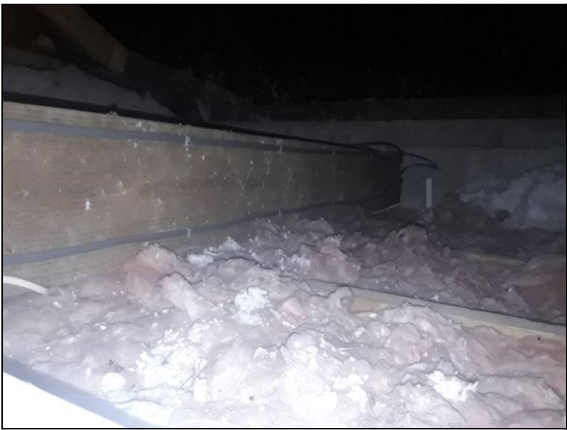
Item No.	Survey Date:	Survey Type	Floor	Analysis
	32	22 Feb 2023	Refurbishment Survey	Roof Void	N/A
	Building	Room	Item	Quantity	Removal Category
	Chittlehampton Village Hall	Entrance Lobby (R02)	Fibreglass insulation quilt No suspect materials found	N/A	-
	Sample No (S,SP,P,As)	Product Type	Surface Treatment	Condition	Accessibility
	Visual (P)	N/A	N/A	N/A	N/A
	Material Risk Score	N/A			
	Recommended action	No further action required			
Surveyor comments	N/A

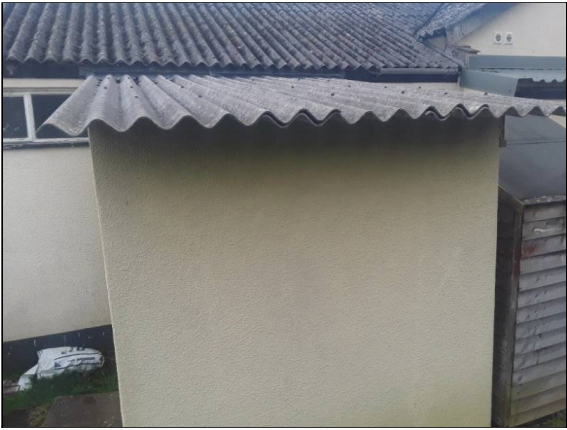
Item No.	Survey Date:	Survey Type	Floor	Analysis
	35	22 Feb 2023	Refurbishment Survey	External	N/A
	Building	Room	Item	Quantity	Removal Category
	Chittlehampton Village Hall	Externals (E01)	Modern corrugated roof sheets to low level lean to roof No suspect materials found	N/A	-
	Sample No (S,SP,P,As)	Product Type	Surface Treatment	Condition	Accessibility
	Visual (P)	N/A	N/A	N/A	N/A
	Material Risk Score	N/A			
Recommended action	No further action required				
Surveyor comments	N/A

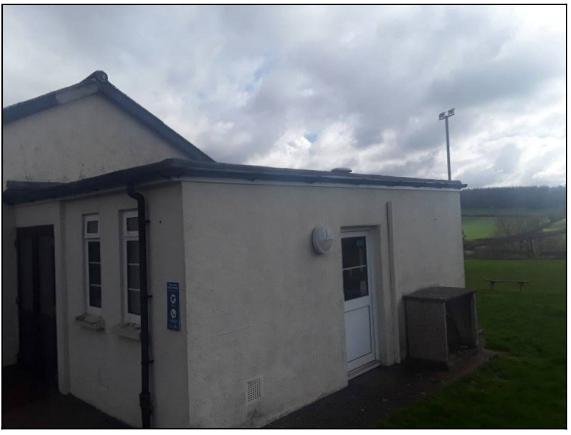
Item No.	Survey Date:	Survey Type	Floor	Analysis
	40	22 Feb 2023	Refurbishment Survey	External	No Asbestos Detected
	Building	Room	Item	Quantity	Removal Category
	Chittlehampton Village Hall	Externals (E01)	Bitumen felt to flat roof as seen	N/A	-
	Sample No (S,SP,P,As)	Product Type	Surface Treatment	Condition	Accessibility
	MF009807 (S)	N/A	N/A	N/A	N/A
	Material Risk Score	N/A			
Recommended action	No further action required				
Surveyor comments	N/A
